# The effect of existing damage on the seismic performance of a historical masonry structure: a site-specific assessment

Bilal Tayfur<sup>1</sup> · Osman Tunca<sup>2</sup> · Musa Artar<sup>1</sup> · Serdar Çarbaş<sup>2</sup>

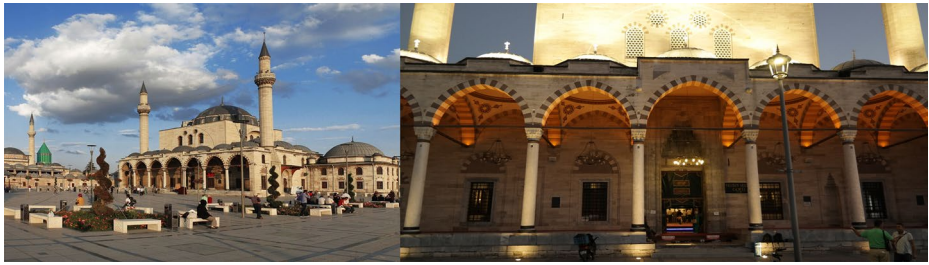
**Fig. 1** Karatay Sultan Selim Mosque

In this section, architectural and geometric properties, historical background, and existing damage conditions of the Karatay Sultan Selim Mosque are presented. In addition to the above information, the results of the non-destructive field tests are also given in this section. Images of Karatay Sultan Selim Mosque can be seen in Fig. 1. The structure is located in the
